APPLIED REMOTE SENSING PROGRAM (ARSP) ANNUAL REPORT

An Annual Report of Work Performed Under
NASA Grant No. NGL 03-002-313

OFFICE OF ARID LANDS STUDIES
University of Arizona
Tucson, Arizona

June, 1976

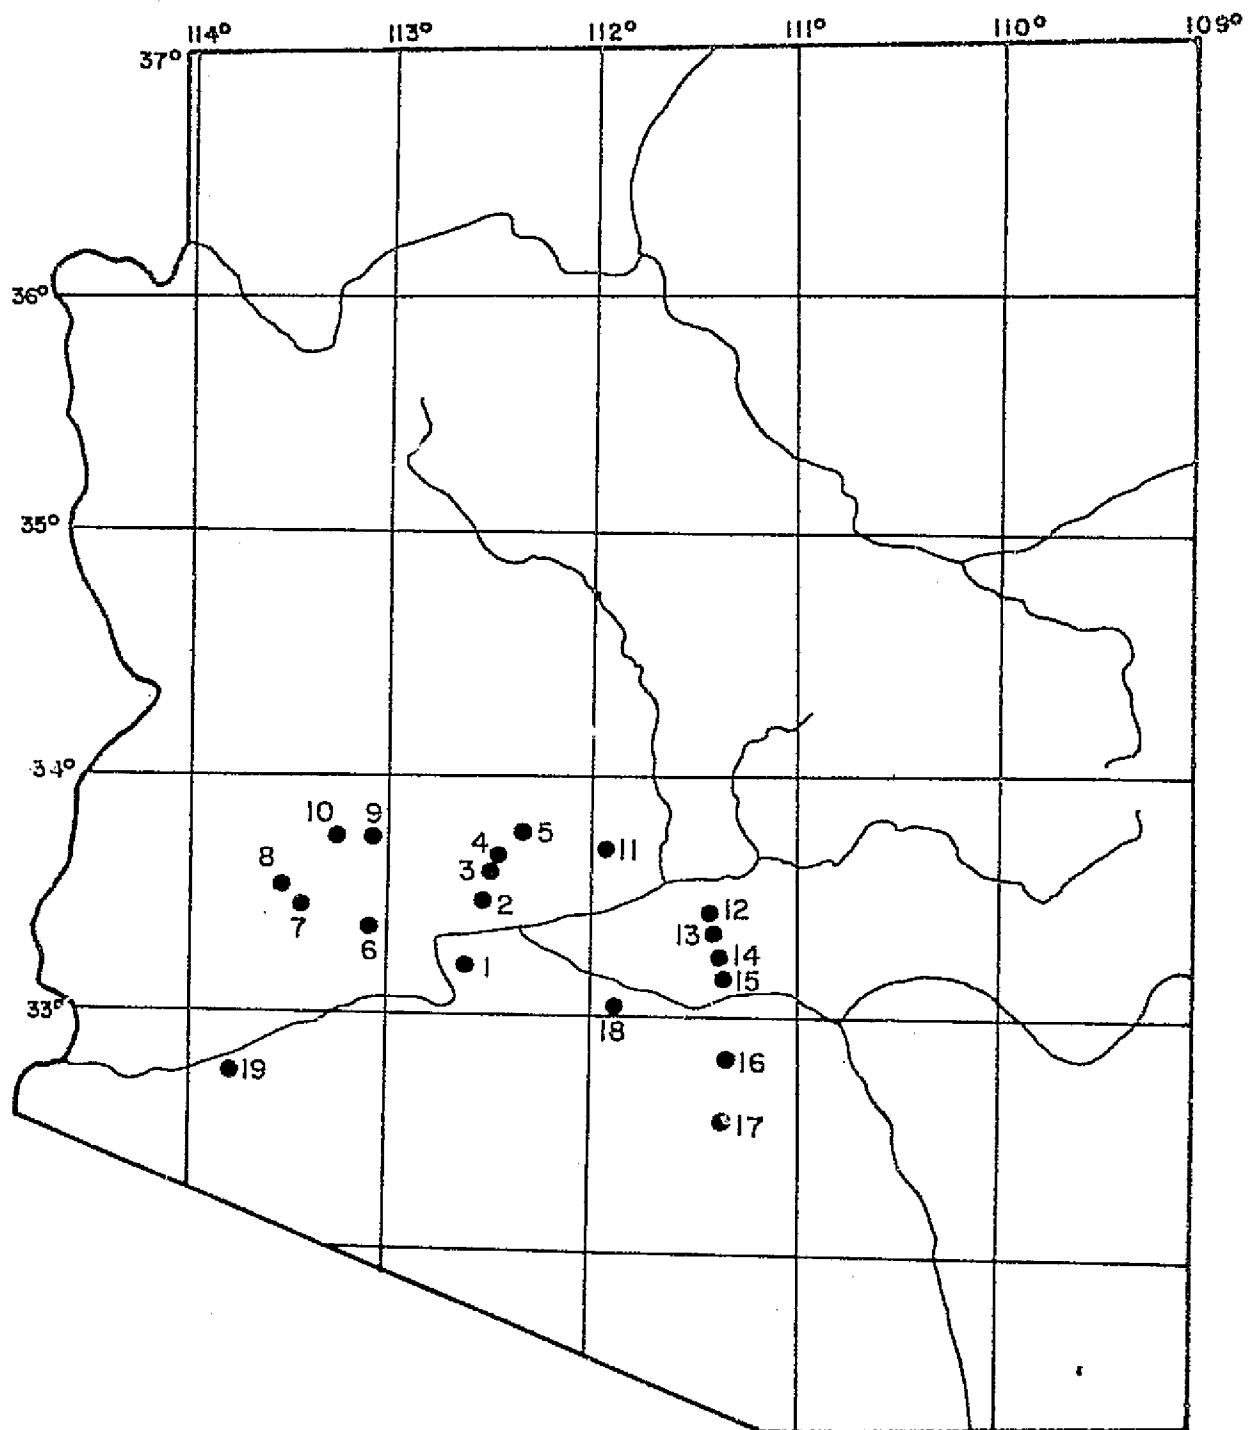
Figure 2-1. Location of Diversion Structures.

ARSP agreed to undertake an analysis of nineteen of the structures. The structures are all located within the Sonoran Desert of Southwest Arizona as shown in Figure 2-1. The project was jointly funded by the U. S. Soil Conservation Service and the Applied Remote Sensing Program. The complete results of this study are contained in OALS Bulletin 11.

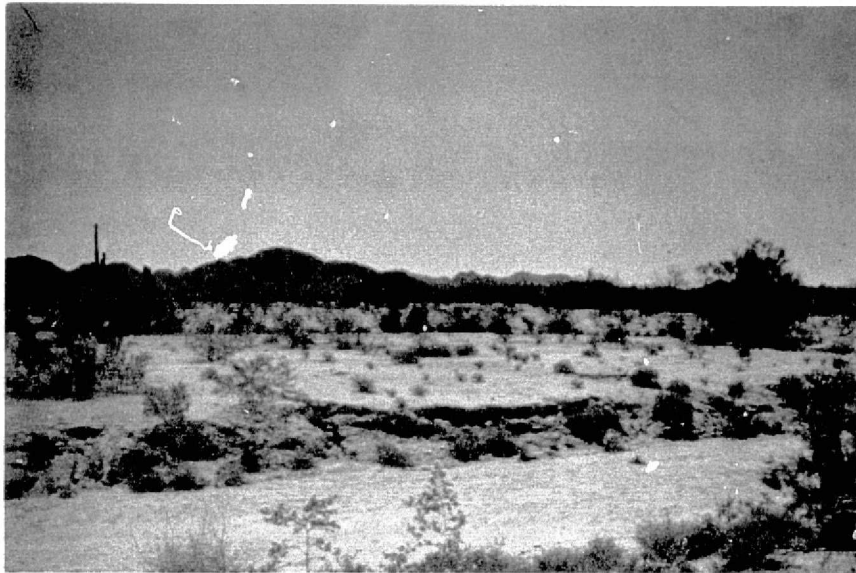
Figure 2-4. Ground truth photograph of upstream vegetation (Structure #1).

The U. S. Highway 80 Structure is characteristic of structures that we found not to impact vegetation. The vegetation on both sides of the structure consists of the Creosote Bush/Foothill Paloverde type with small amounts of brittle-bush, triangle-leaf bursage, and saguaro. Ironwood is common along the washes.

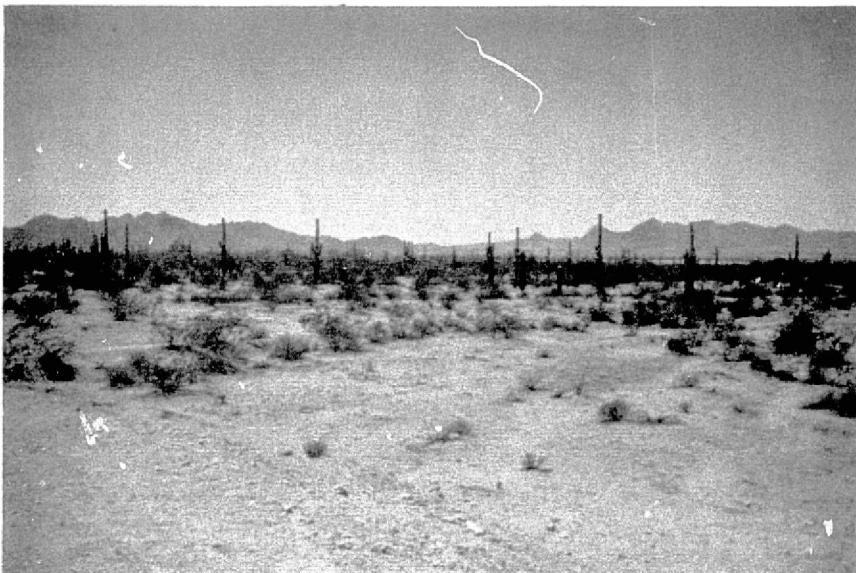
Figure 2-5. Ground truth photo of downstream vegetation (Structure #1).

The vigor of the vegetation immediately downslope from the structure was lower than that of upslope vegetation and vegetation further downslope. However, the affected area extends only about 100 yards downslope from the structure. Creosote bush appears to suffer the greatest loss of vigor.

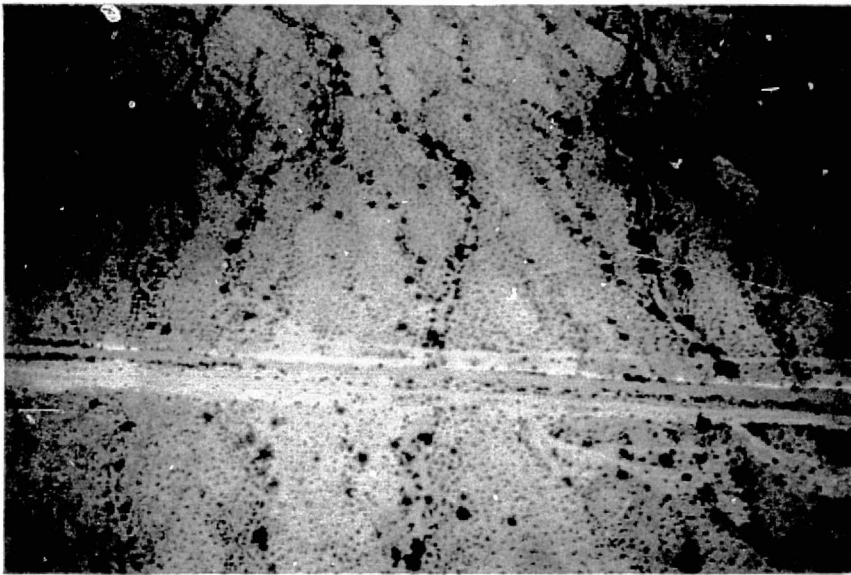
Figure 2-6. Infrared photo of the diversion structure and adjacent upstream and downstream areas (Structure #1).

Although its effect on vegetation has been minimal, the diversion structure has caused a major wash to exist which parallels the structure, just upstream from it. The new wash, which is approximately 15 feet wide, prevents water from

accumulating behind the structure, preventing the occurrence of more luxuriant plant growth upstream.

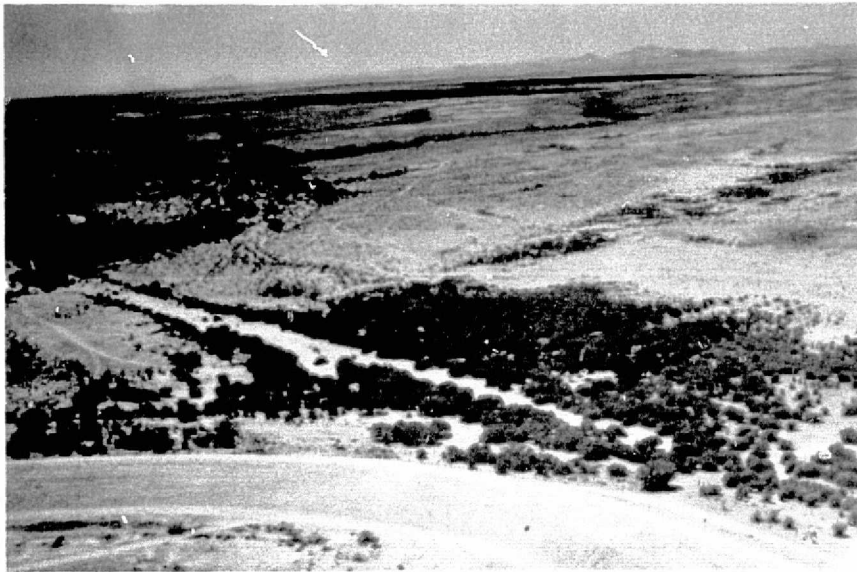
Figure 2-7. Dense stand of vegetation immediately upslope of structure (#5).

The statistics for this site, presented in Table 2-2, support the general conclusions of the previous section. The statistics show a higher vigor, cover, and density upslope than downslope. Moreover, riparian vegetation seems to be much more affected both upslope and downslope, than is interfluvial vegetation.

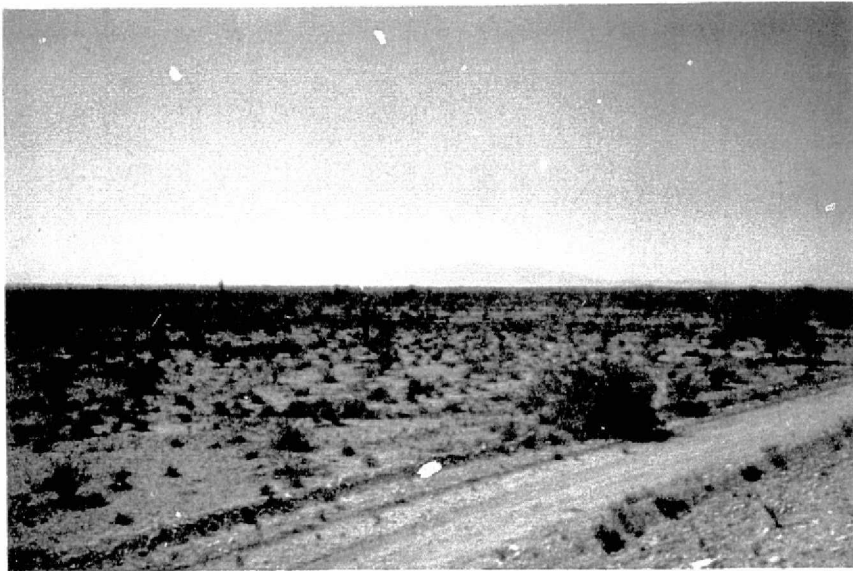
Figure 2-9. Downslope interfluvial vegetation. The Triangle-leaf Bursage/
Creosote Bush type with cholla (Structure #5).

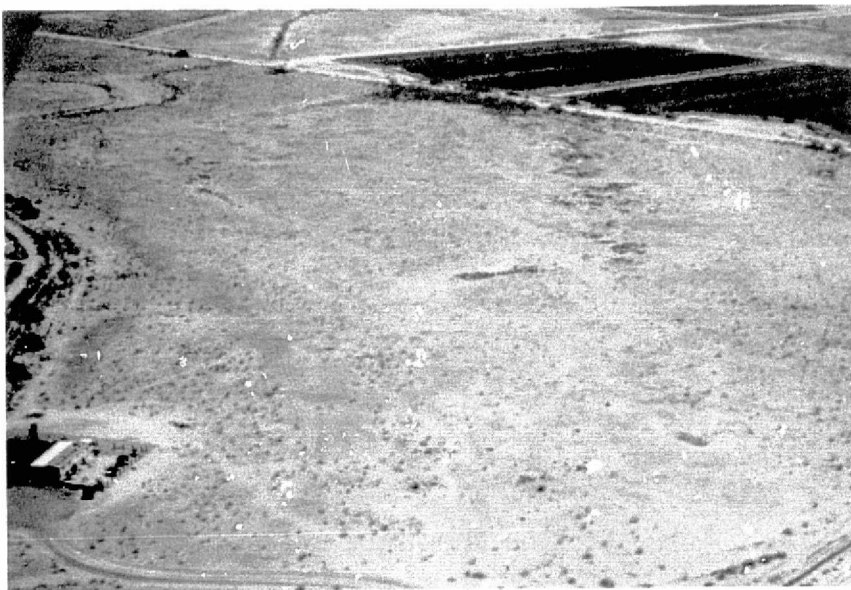
Figure 2-10. Infrared low-altitude photo of downstream vegetation (Structure #5).

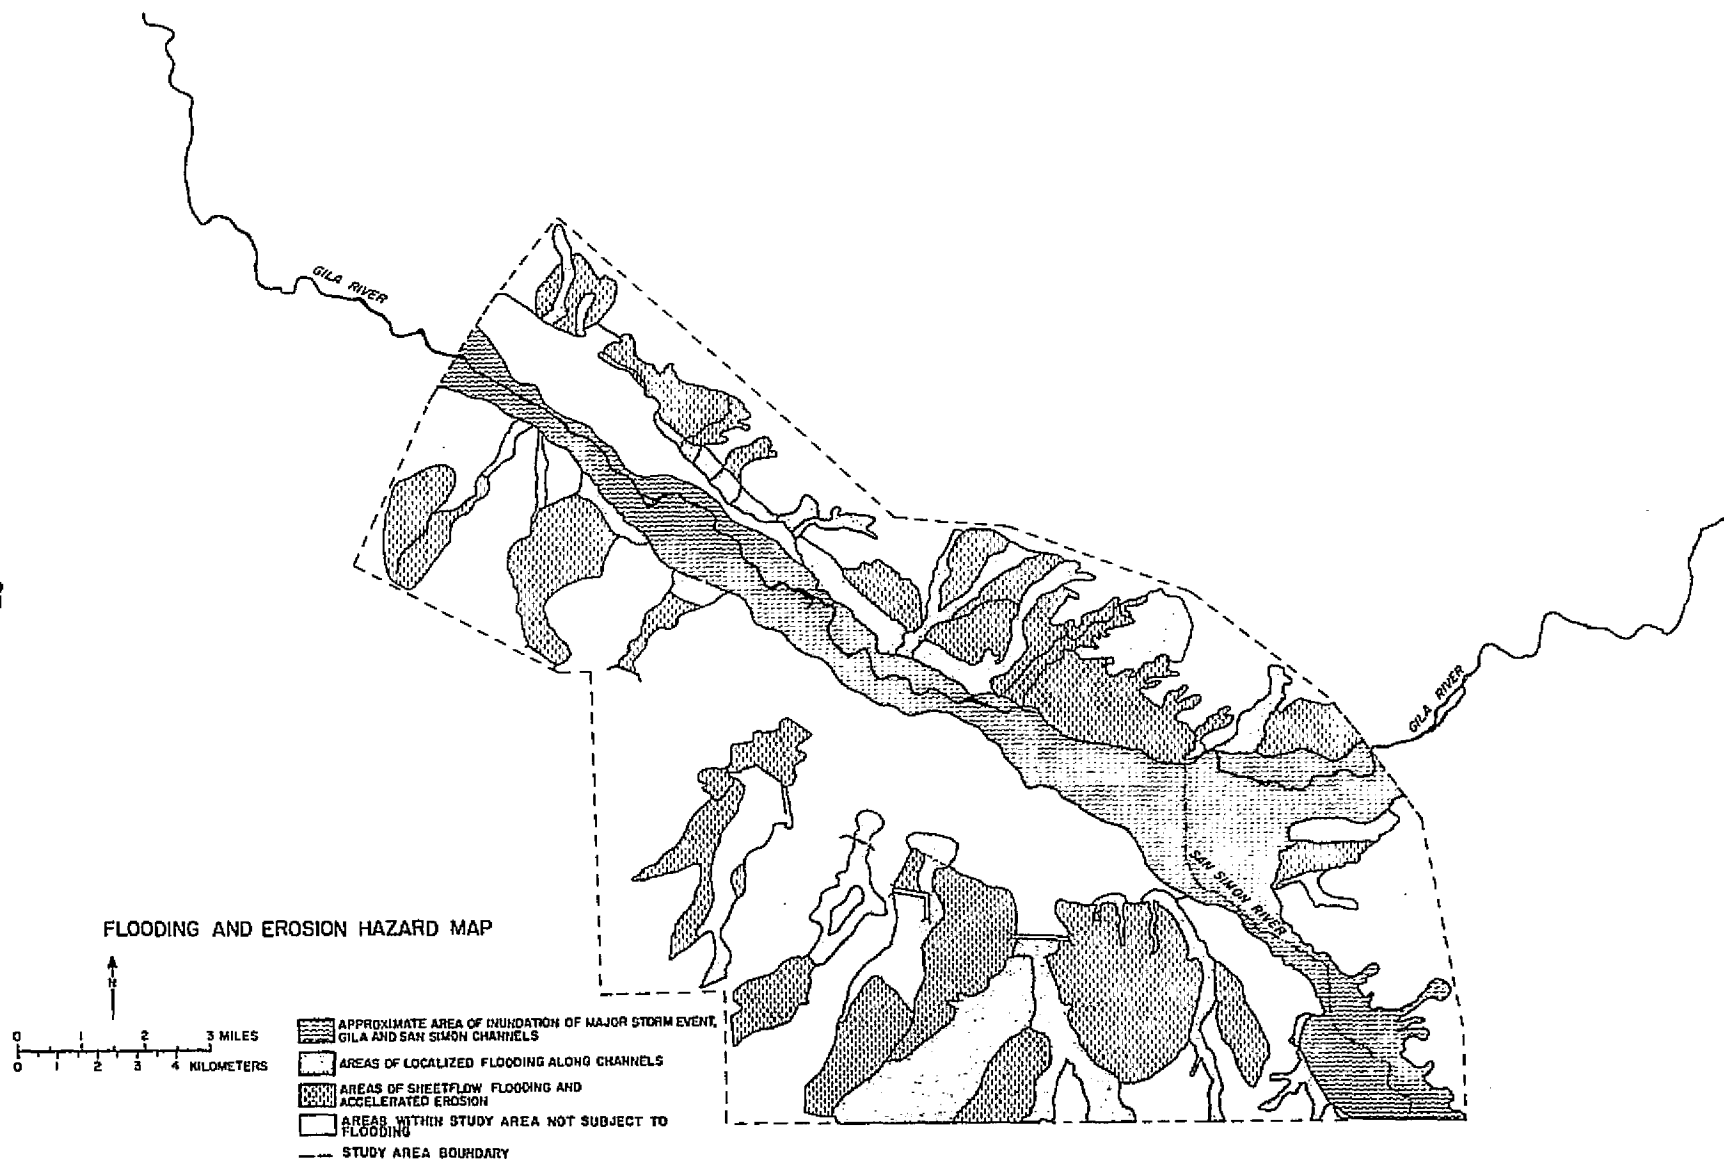
Figure 3-1. Graham County Flooding and Erosion Hazard Map

The need in Graham County was not only for flood and erosion hazard delineations to meet state legislative requirements but also for additional evidence toward settlement of a disputed inundation area boundary. The boundary which was provided for Federal Flood Insurance purposes was, according to county officials and to local history, an underestimation of the actual area subject to considerable flooding. Remote sensing-derived flood hazard mapping has enabled the county to appeal the erroneous delineation at minimal cost when compared to standard engineering procedures.

storm in November, 1972. The flood hazard map developed by ARSP for Graham County will be used to enforce laws directing new development away from areas subject to inundation. The need for such regulation in the project area is immediate due to increasing population pressure as a result of rapid expansion of mining in the area. As a result of the ARSP project there exists now a data base for ordinances controlling further development of flood prone lands.

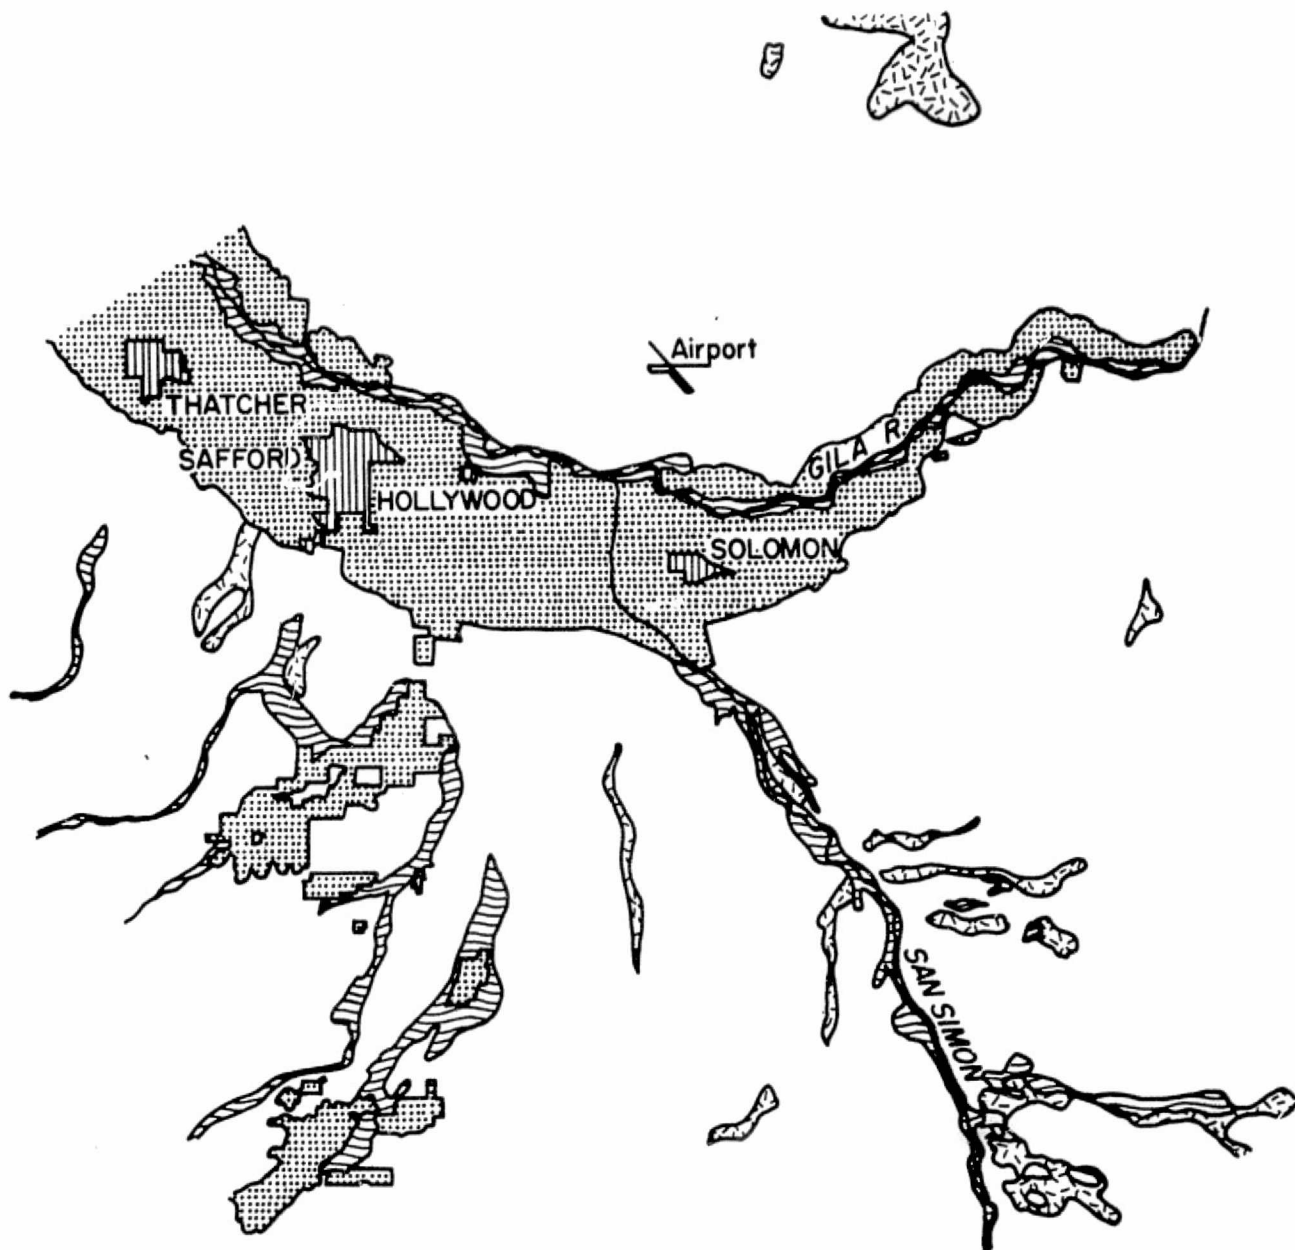
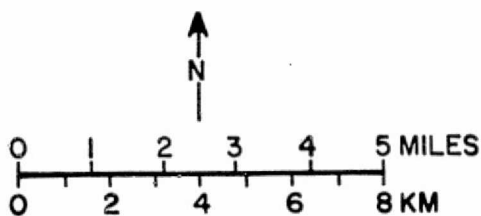
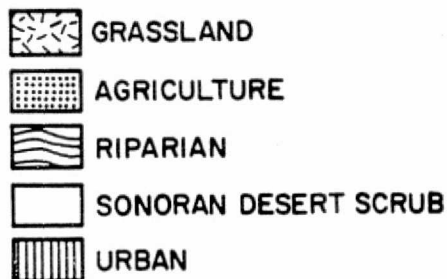
Figure 3-3. Graham County High-Altitude Aircraft
 Interpreted Vegetation Map of Study Area.

VEGETATION MAP OF STUDY AREA
 INTERPRETED FROM NASA HIGH-ALTITUDE
 AIRCRAFT PHOTOGRAPHY IN COLOR INFRARED
 MISSION 72-129 1AUG72

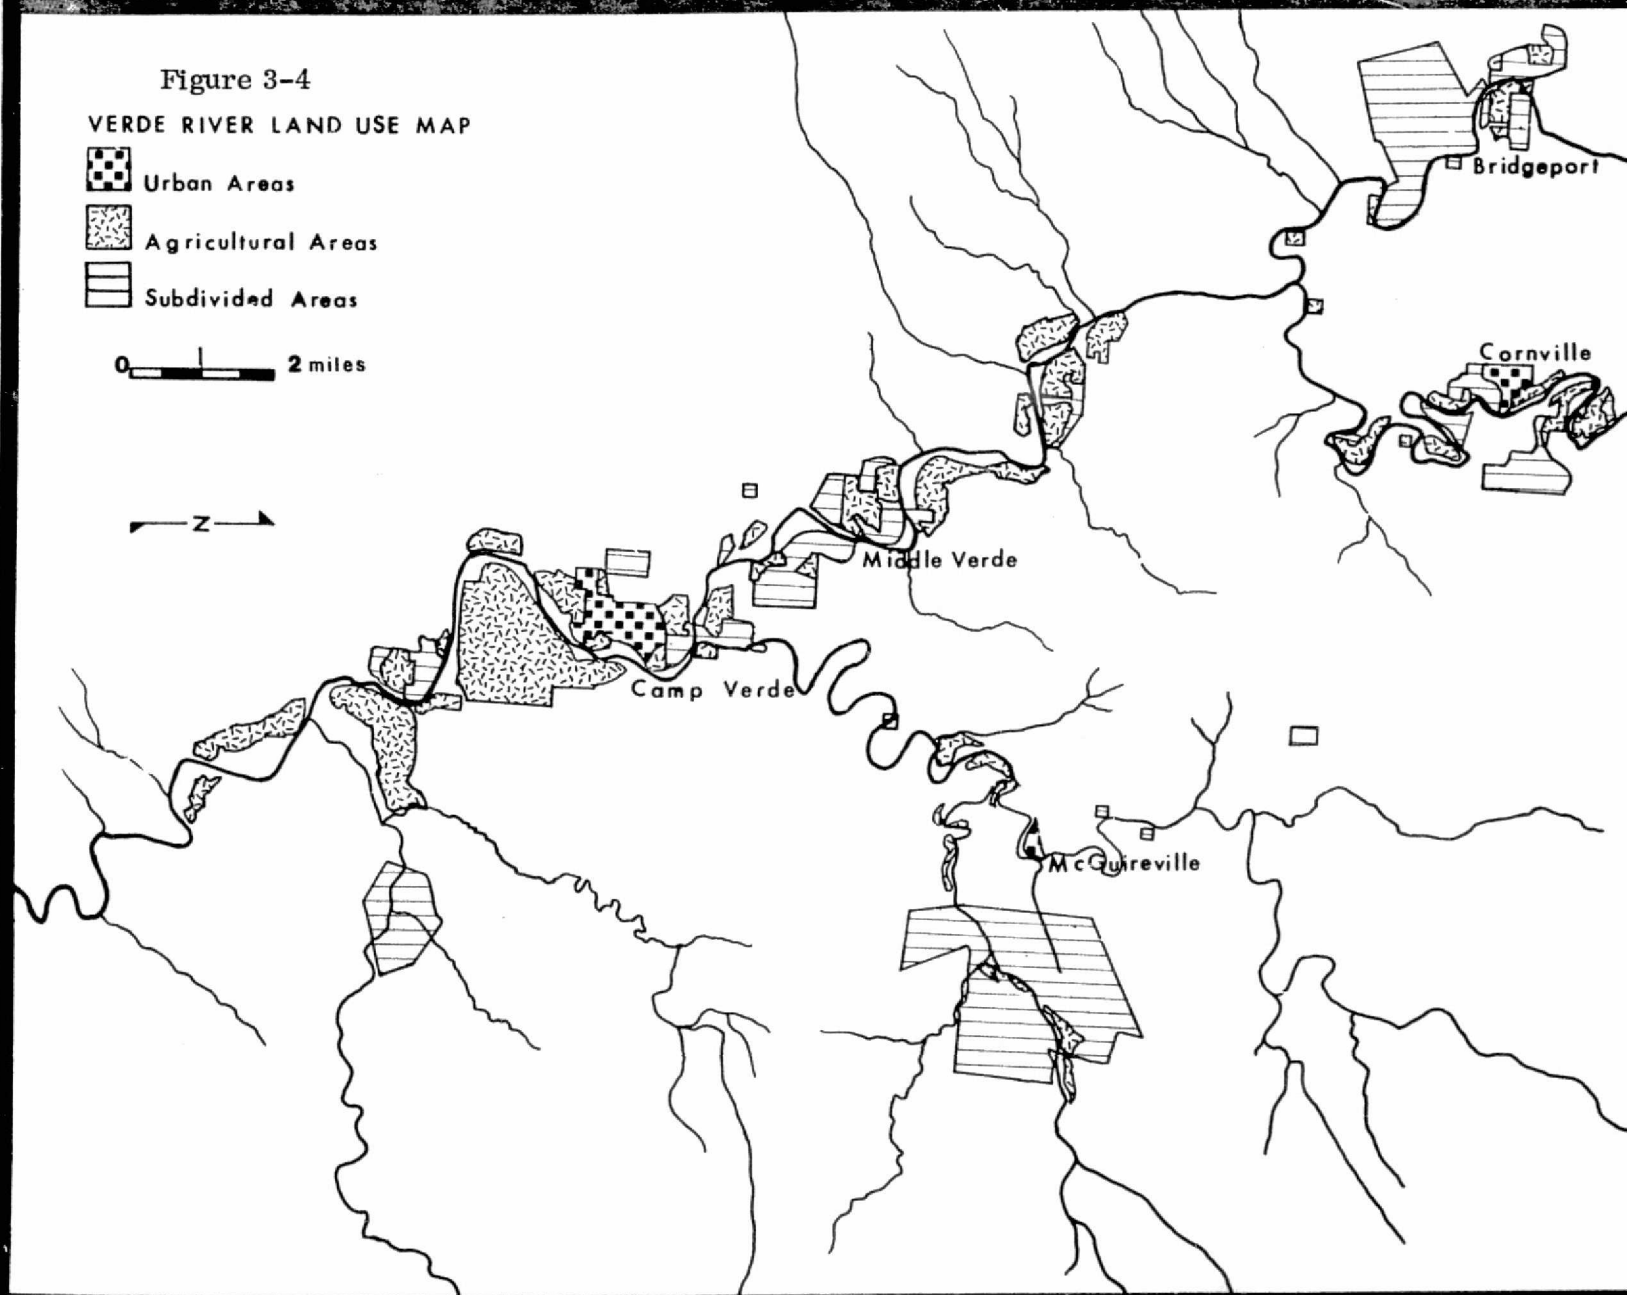
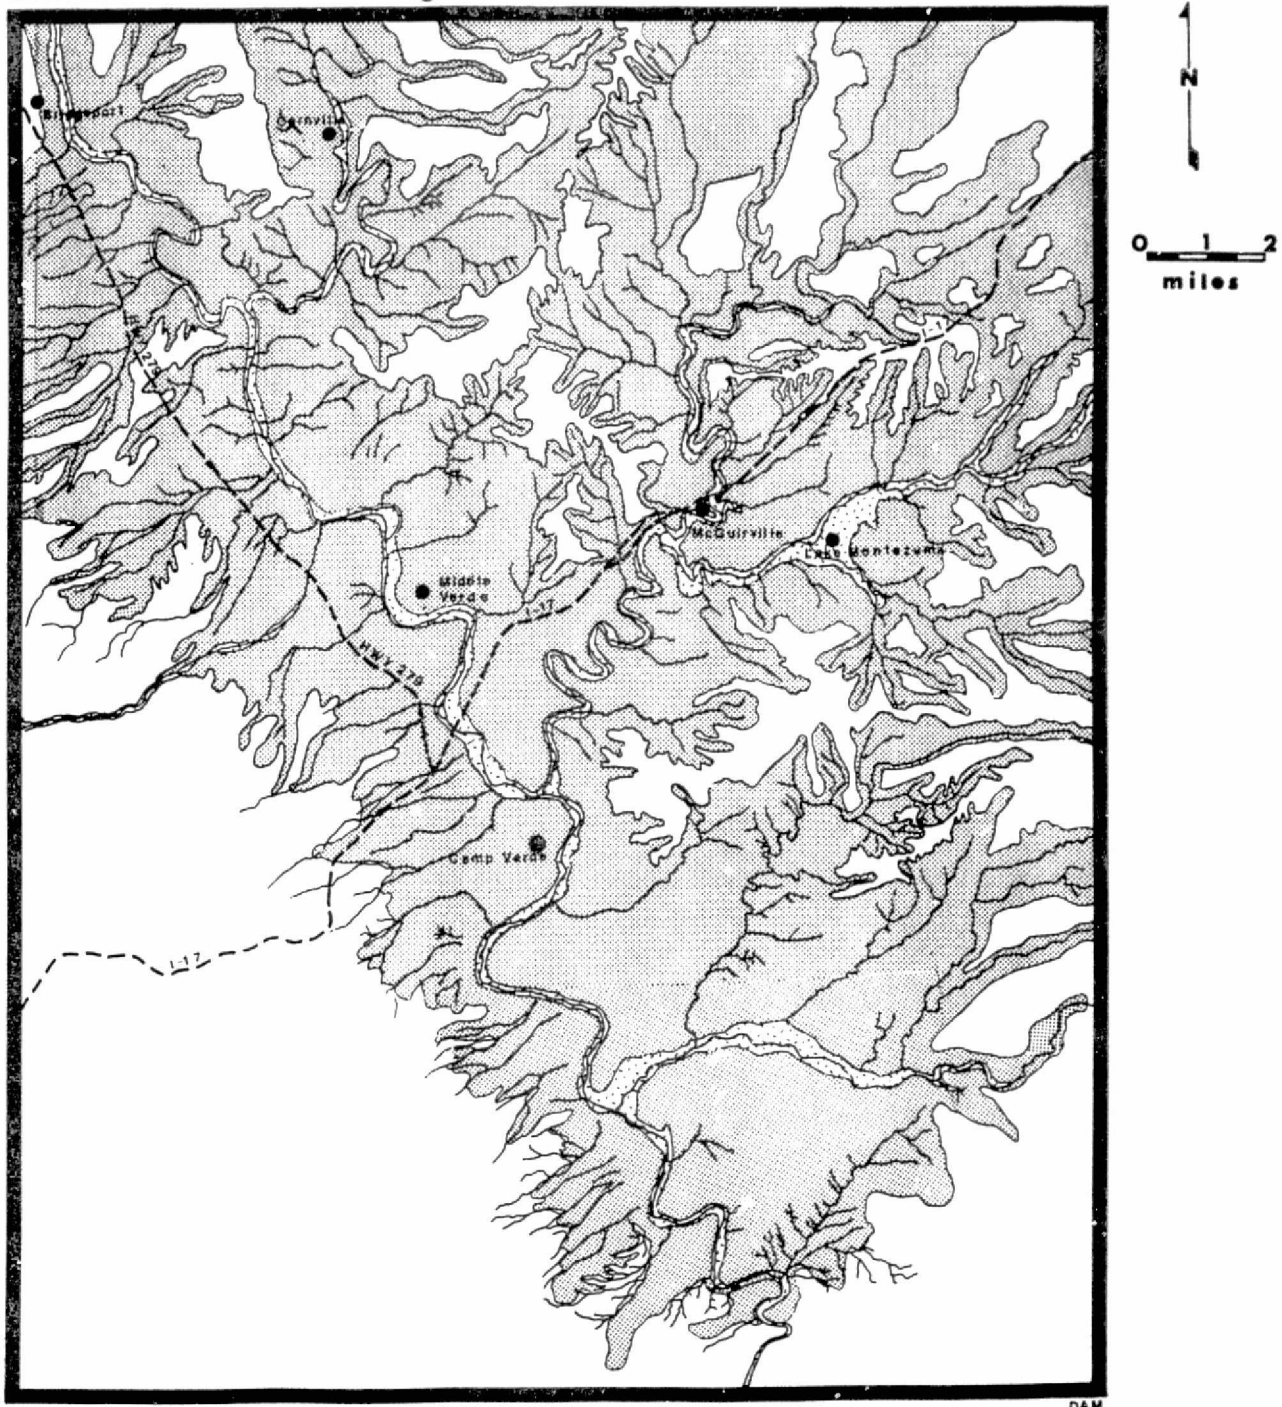
Figure 3-5. Verde River Flood Hazard Map
-31-

Flood Hazard Map of the Verde River Interpreted from High Altitude Aircraft Photography, ERAP Mission 155, August 1971

- Area of localized Flooding Along Channels
- Area of Sheetflow Flooding and Accelerated Erosion

The area selected for flood hazard analysis was the rapidly developing region surrounding Camp Verde and Cottonwood along the Verde River, Wet Beaver Creek, and West Clear Creek drainages. This area is under pressure of speculative land subdivision, and has a history of severe flooding on the major channels and ephemeral streams. Some subdivided land in the study lies within the main channel of Wet Beaver Creek.

Imagery from LANDSAT-1 and high altitude natural color photographs were interpreted to develop land use (Figure 3-4) and flood hazard maps (Figure 3-5) for this central Arizona county. A county-wide land use map was made from 1972 and '73 Arizona Land Use Experiment photography, using black and white prints at 1:120,000 scale. Changes in agricultural and rangeland use patterns were interpreted from enlarged (1:250,000) LANDSAT color composites, and used to update the data derived from the U-2 flights, which were two-to-three years old.

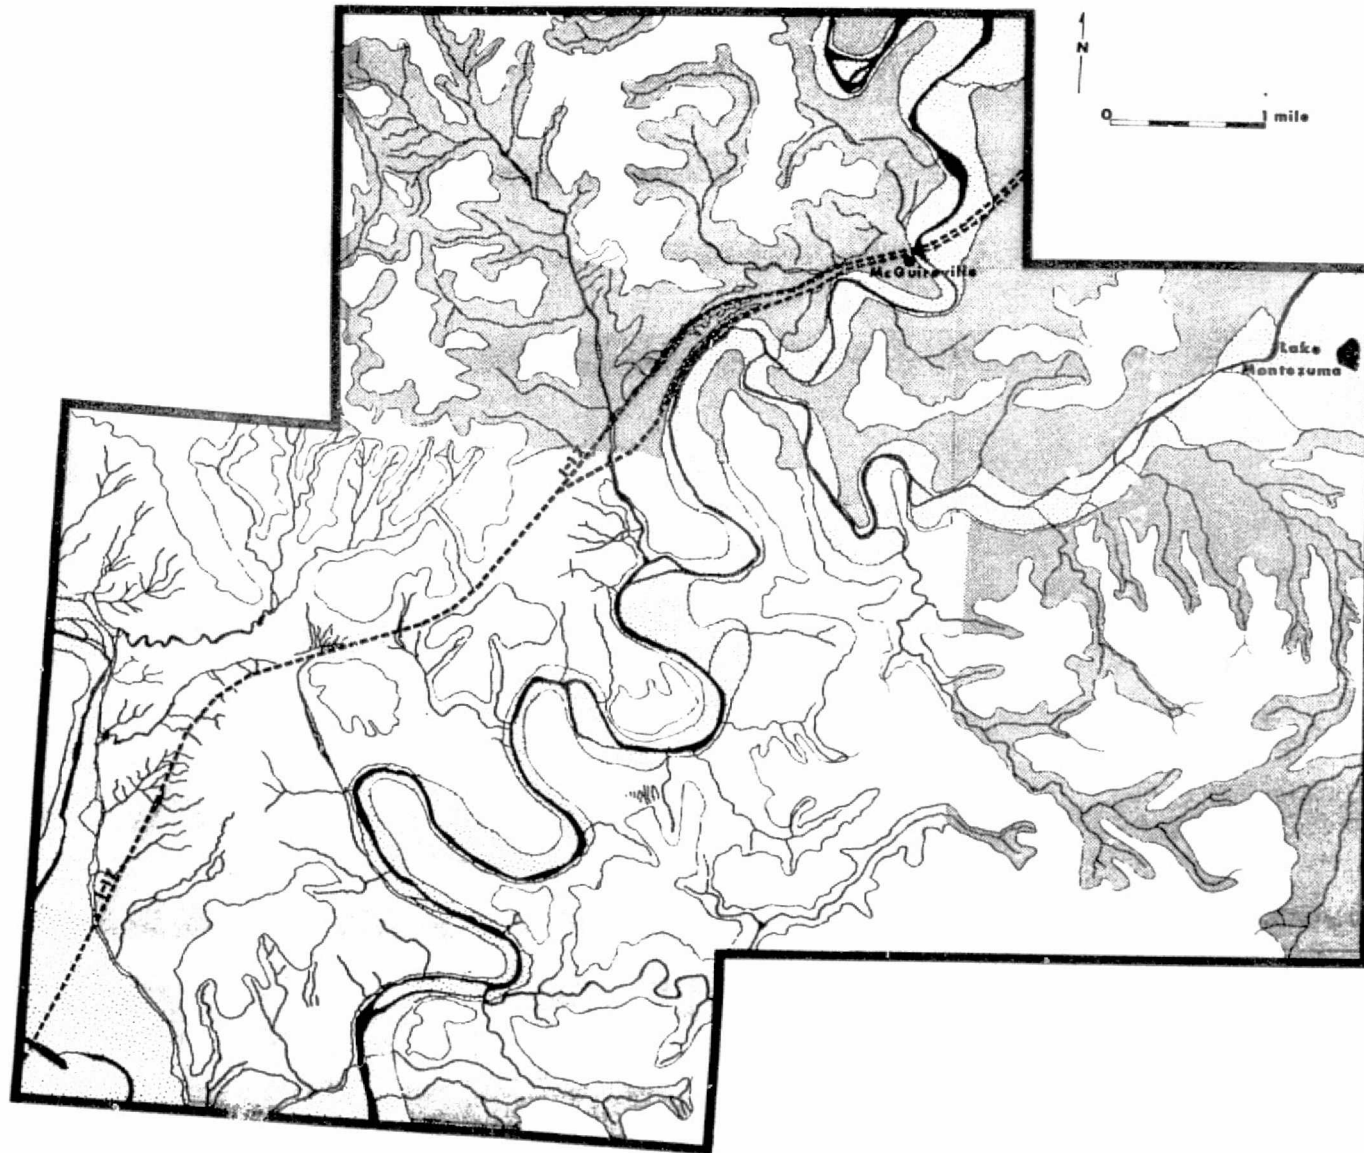
Figure 3-6. West Clear Creek Flood Hazard Map

**Flood Hazard Map of West Clear Creek
Interpreted from U.S. Forest Service Imagery**

- ☒ Area of Localized Flooding along Channels
- ☐ Area of Sheetflow Flooding and Accelerated Erosion

The larger scale and high resolution qualities of the imagery enabled the operator to make very accurate interpretations of flood hazard areas (Figure 3-6) and land use patterns (Figure 3-7). The same procedure was followed in delineating the floodplain and the land use in this area as was used in the U-2 interpretations.

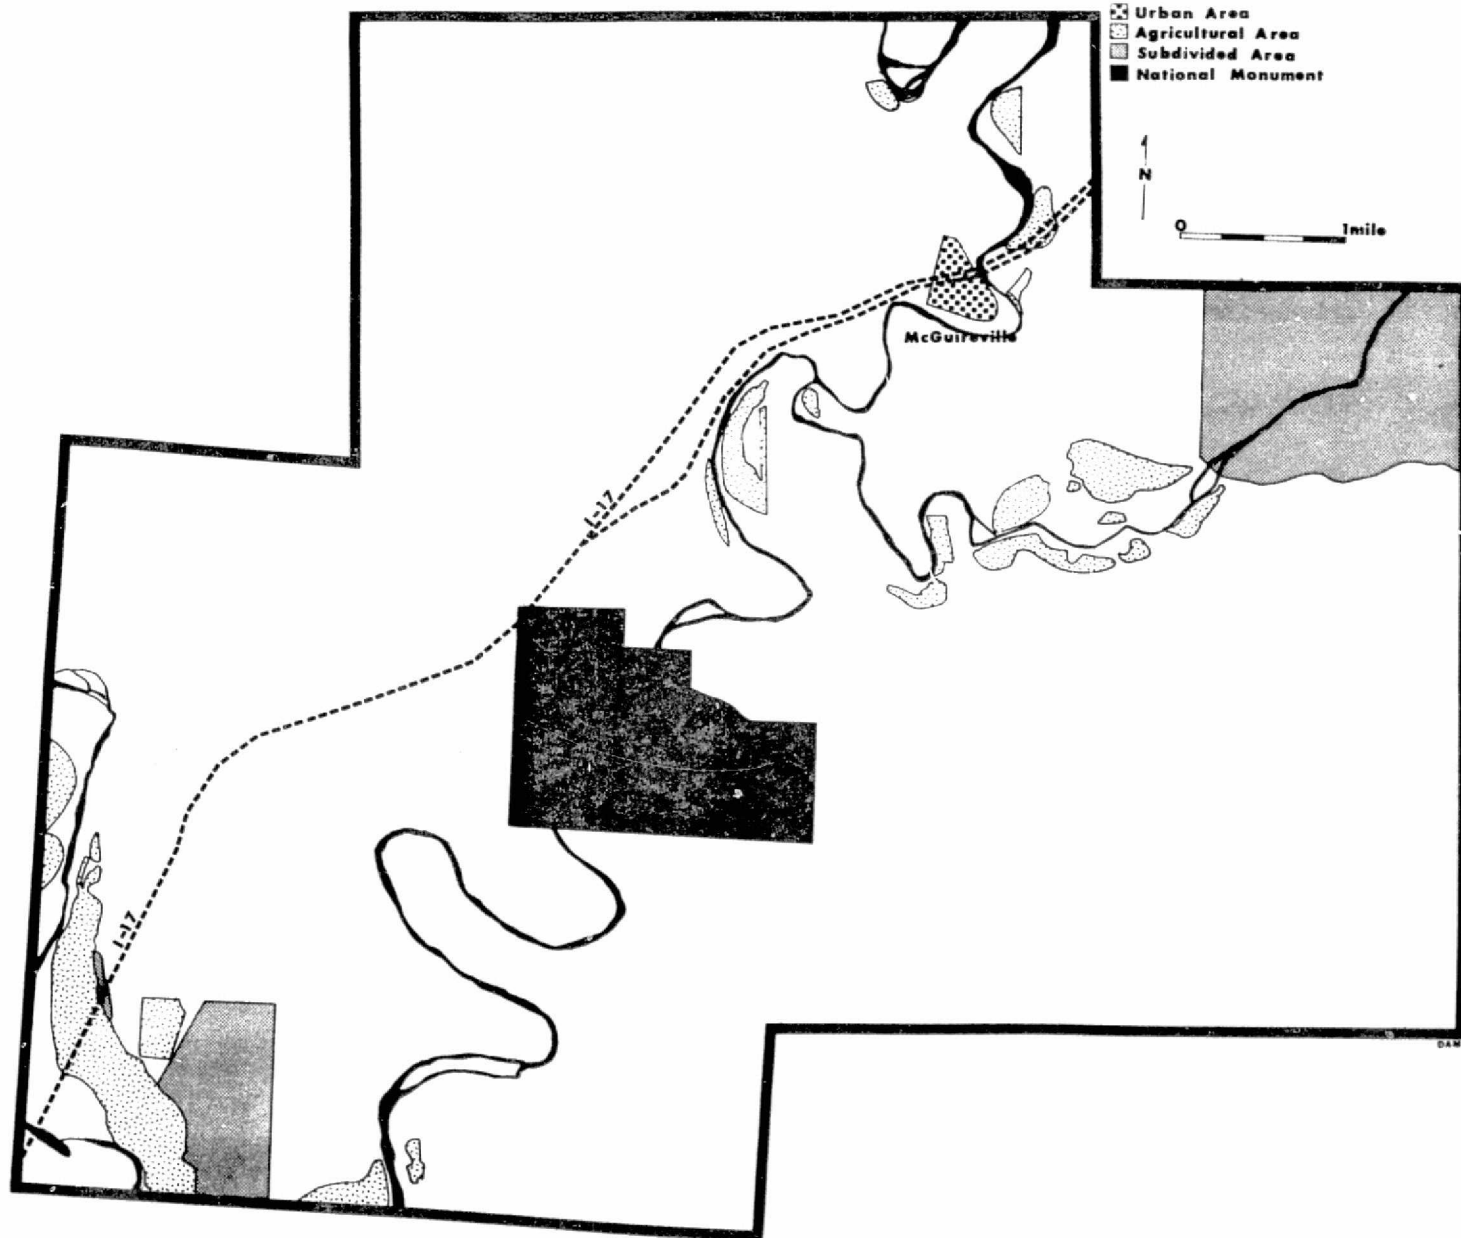
Figure 3-7. West Clear Creek Land Use Map

**Land Use Map of West Clear Creek Interpreted
from U.S. Forest Service Imagery**
